Re: St. Bede's Episcopal Church, St. Bede Episcopal Church West Wing, Construction General Permit Compliance Evaluation, SIC 1542; NPDES Permit No. NMR1000WX; December 21, 2017

NPDES Construction General Permit Inspection Report – State of New Mexico

St. Bede's Episcopal Church – West Wing
1601 St. Francis Drive; Santa Fe, NM
Construction General Permit – Compliance Evaluation Inspection
Date: December 21, 2017

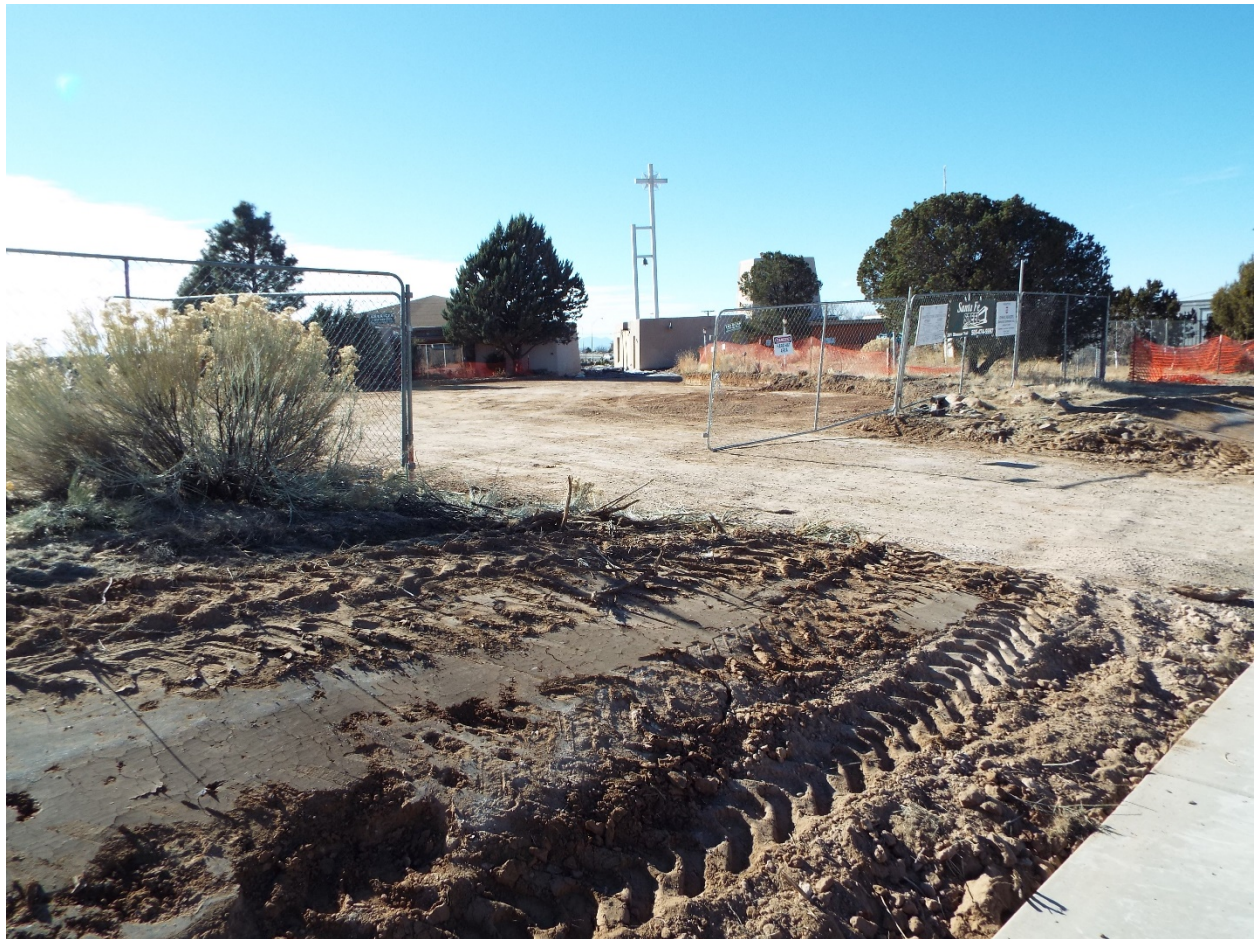
NMED/SWQB
Official Photograph Log
Photo # 1

The site has two exits. There were no aggregate stone with an underling geotextile or non-woven filter fabric and turf mats at either exit.

Photographer: Daniel Valenta	Date: 12-21-2017	Time: 0742 Hours
City/County: Santa Fe / Santa Fe		State: New Mexico
Location: St. Bedes Episcopal Church; 1601 St. Francis Drive; Santa Fe, NM		
Subject: Entrance to construction site

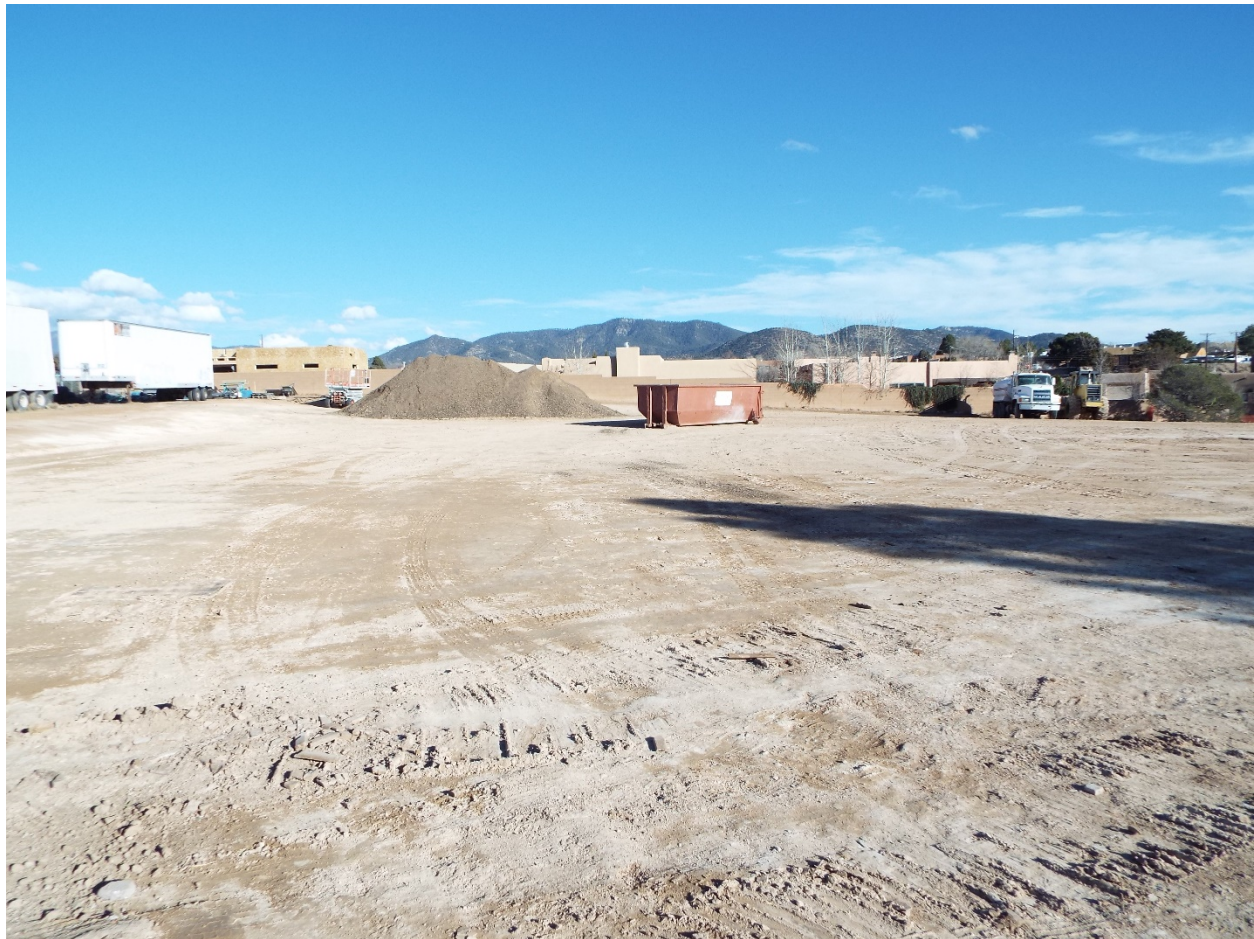
NMED/SWQB
Official Photograph Log
Photo # 2

There is a roll-off waste container on site. The waste container was uncovered. The permit requires in Part 2.3.3.e that the containers be closed when not in use and be closed at the end of the business day for those containers that are actively used throughout the day. If there is no lid, the operator should cover the container with a tarp, or a similarly effective means designed to minimize the discharge of pollutants.

Photographer: Daniel Valenta	Date: 12-21-2017	Time: 1446 Hours
City/County: Santa Fe / Santa Fe		State: New Mexico
Location: St. Bedes Episcopal Church; 1601 St. Francis Drive; Santa Fe, NM		
Subject: Cleared site with stockpile of asphalt and uncovered trash bin

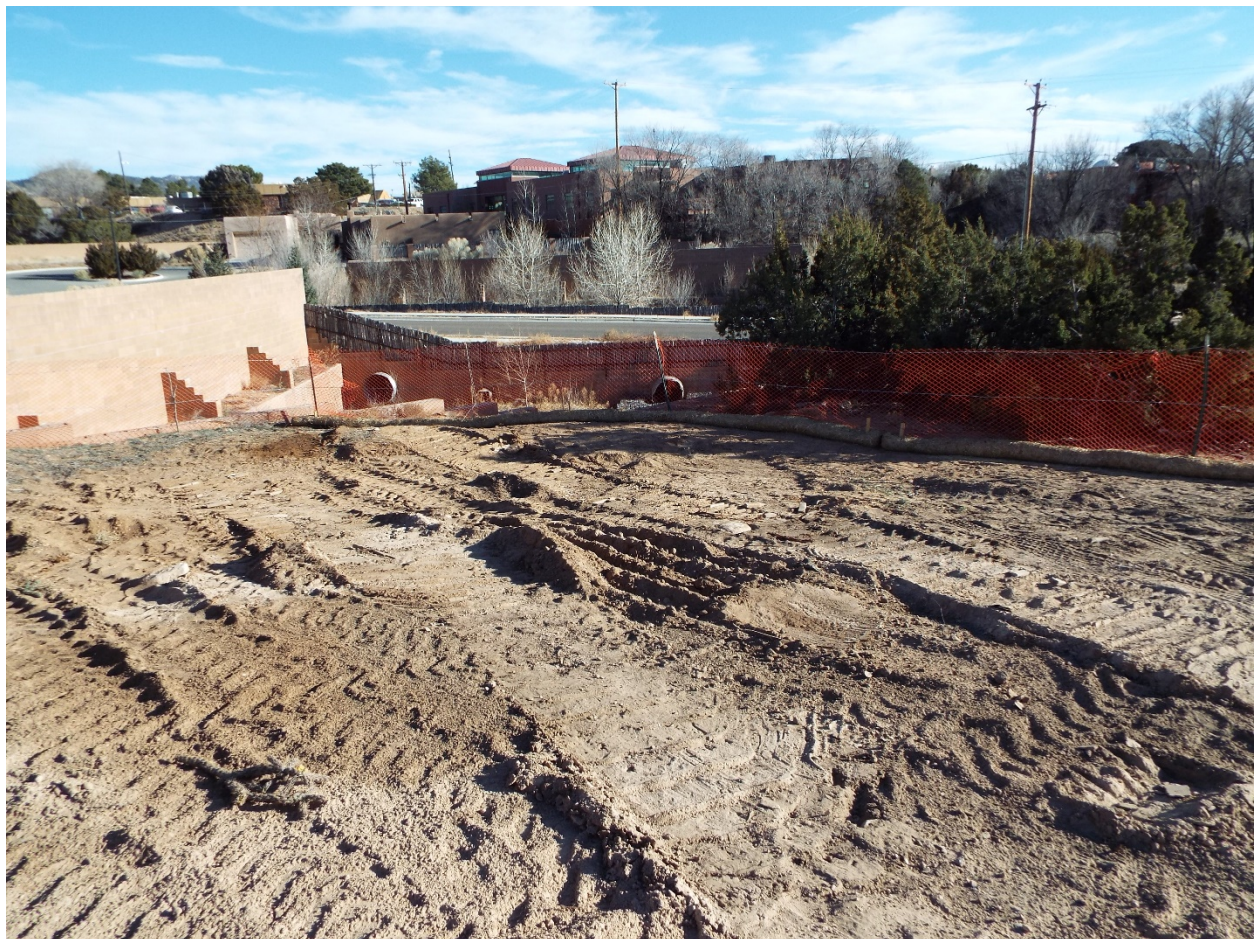
NMED/SWQB
Official Photograph Log
Photo # 3

The site slopes to the southeast into an unnamed ephemeral arroyo. There are waddles along the perimeter of the site. There are no other BMPs to control stormwater velocity and minimize erosion near the discharge point.

Photographer: Daniel Valenta	Date: 12-21-2017	Time: 1447 Hours
City/County: Santa Fe / Santa Fe		State: New Mexico
Location: St. Bedes Episcopal Church; 1601 St. Francis Drive; Santa Fe, NM		
Subject: Southeast corner of construction site; discharge to unnamed ephemeral arroyo.

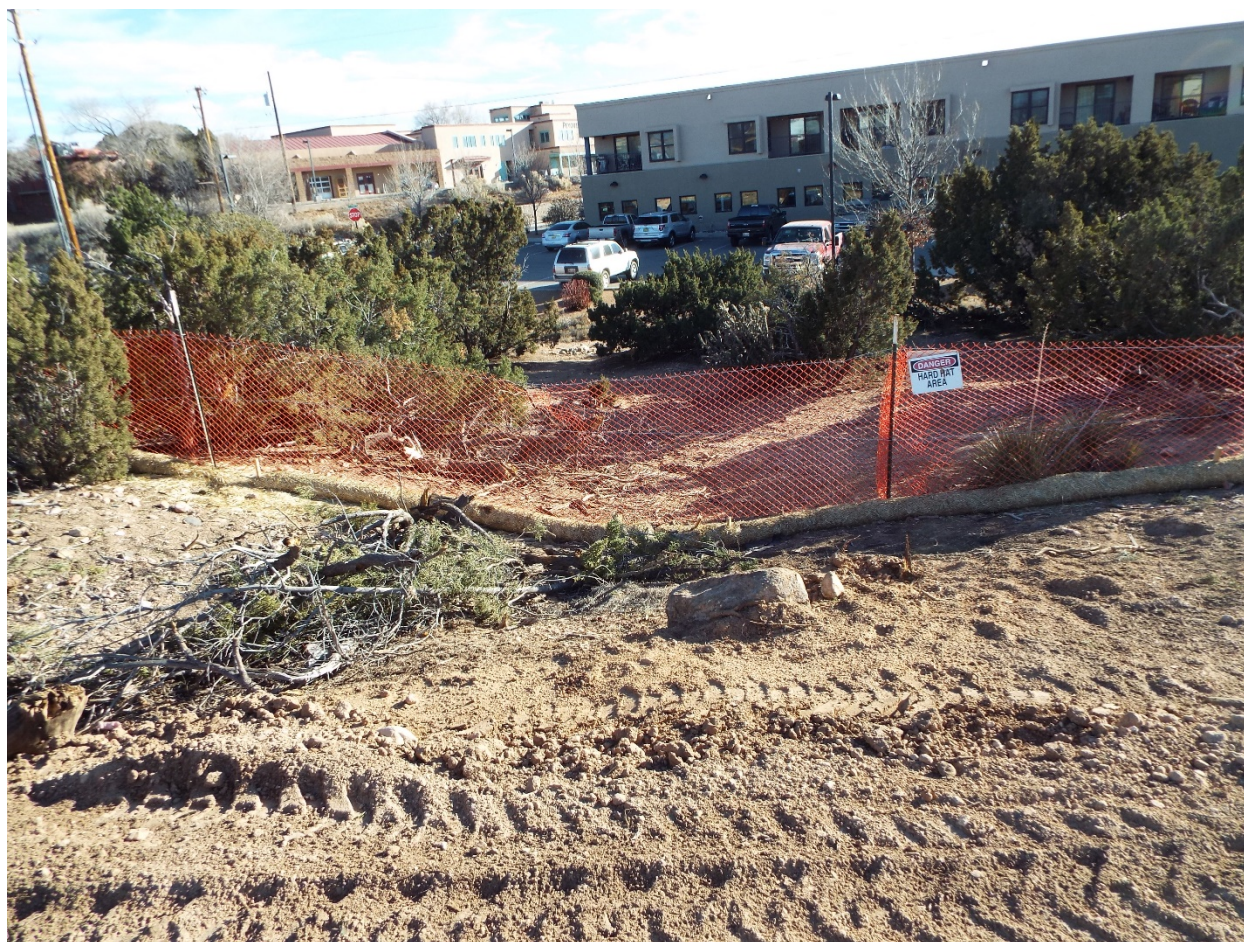
NMED/SWQB
Official Photograph Log
Photo # 4

Photographer: Daniel Valenta	Date: 12-21-2017	Time: 1452 Hours
City/County: Santa Fe / Santa Fe		State: New Mexico
Location: St. Bedes Episcopal Church; 1601 St. Francis Drive; Santa Fe, NM		
Subject: Apparent discharge point (note: the rill beyond the orange construction fencing).

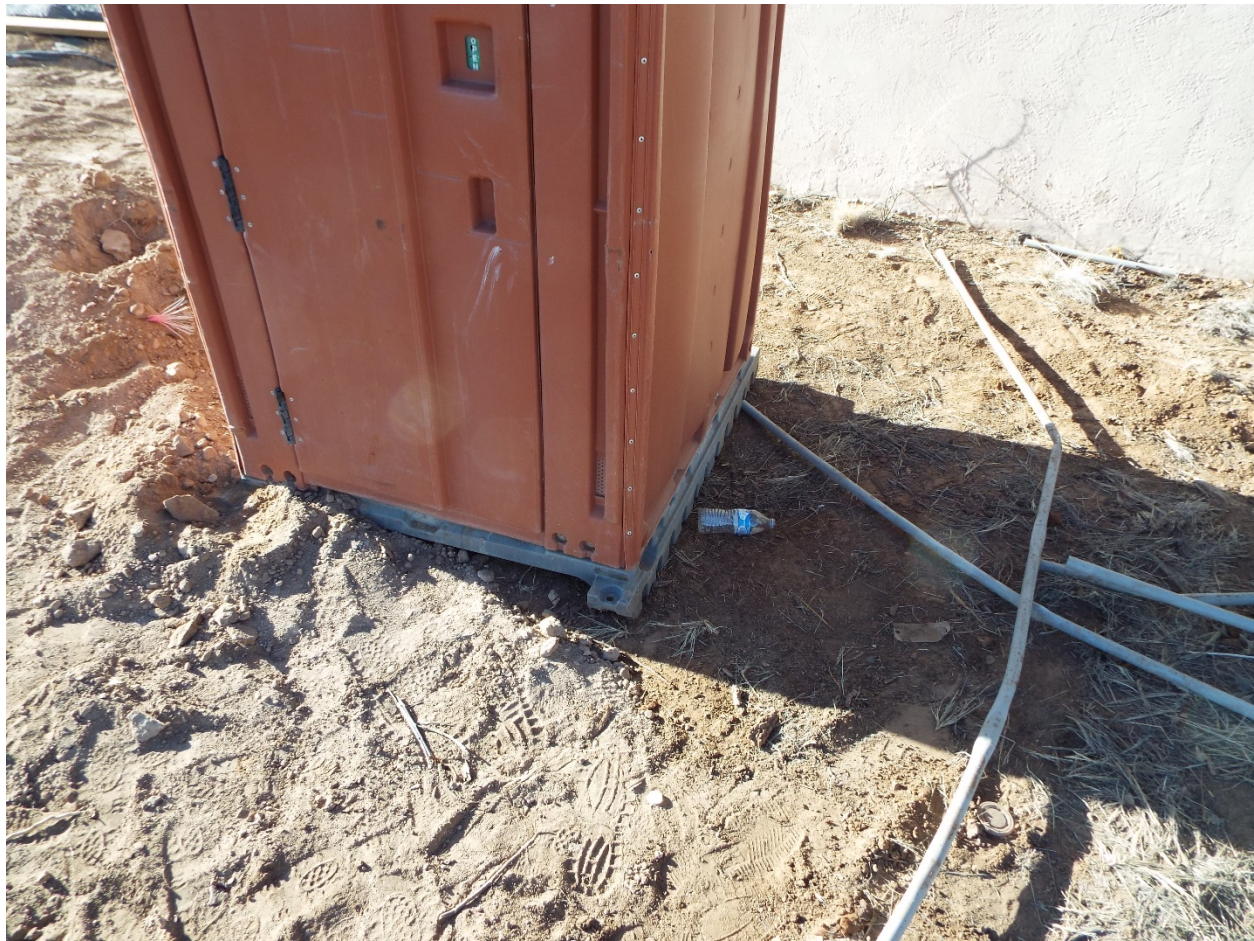
NMED/SWQB
Official Photograph Log
Photo # 5

The site has two portable toilets. Neither toilet was secure to avoid them being tipped or knocked over.

Photographer: Daniel Valenta	Date: 12-21-2017	Time: 1453 Hours
City/County: Santa Fe / Santa Fe		State: New Mexico
Location: St. Bedes Episcopal Church; 1601 St. Francis Drive; Santa Fe, NM		
Subject: Portable toilet that has not been secured.

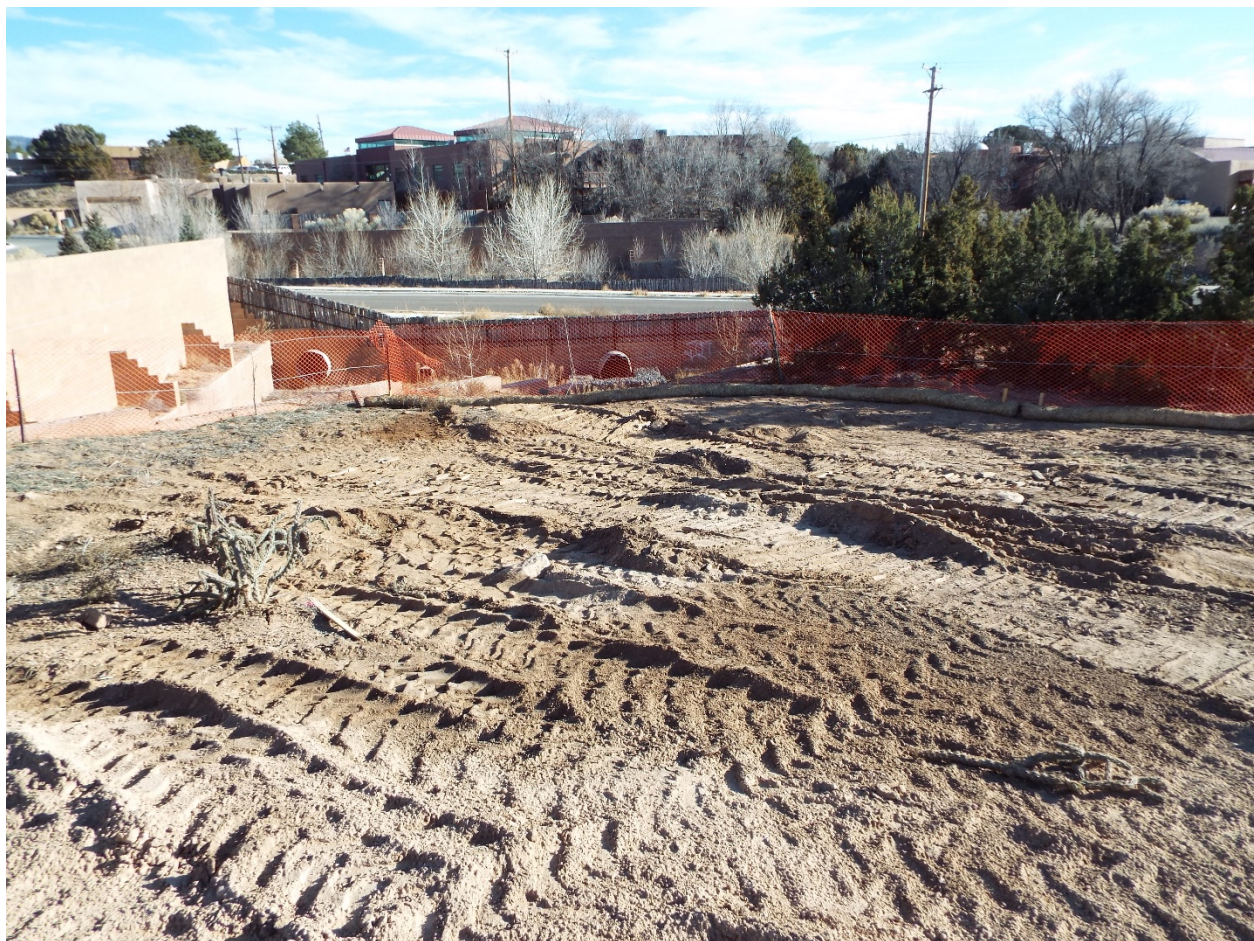
NMED/SWQB
Official Photograph Log
Photo # 6

Photographer: Daniel Valenta	Date: 12-21-2017	Time: 1453 Hours
City/County: Santa Fe / Santa Fe		State: New Mexico
Location: St. Bedes Episcopal Church; 1601 St. Francis Drive; Santa Fe, NM		
Subject: Discharge location named in the Site Map of the SWPPP

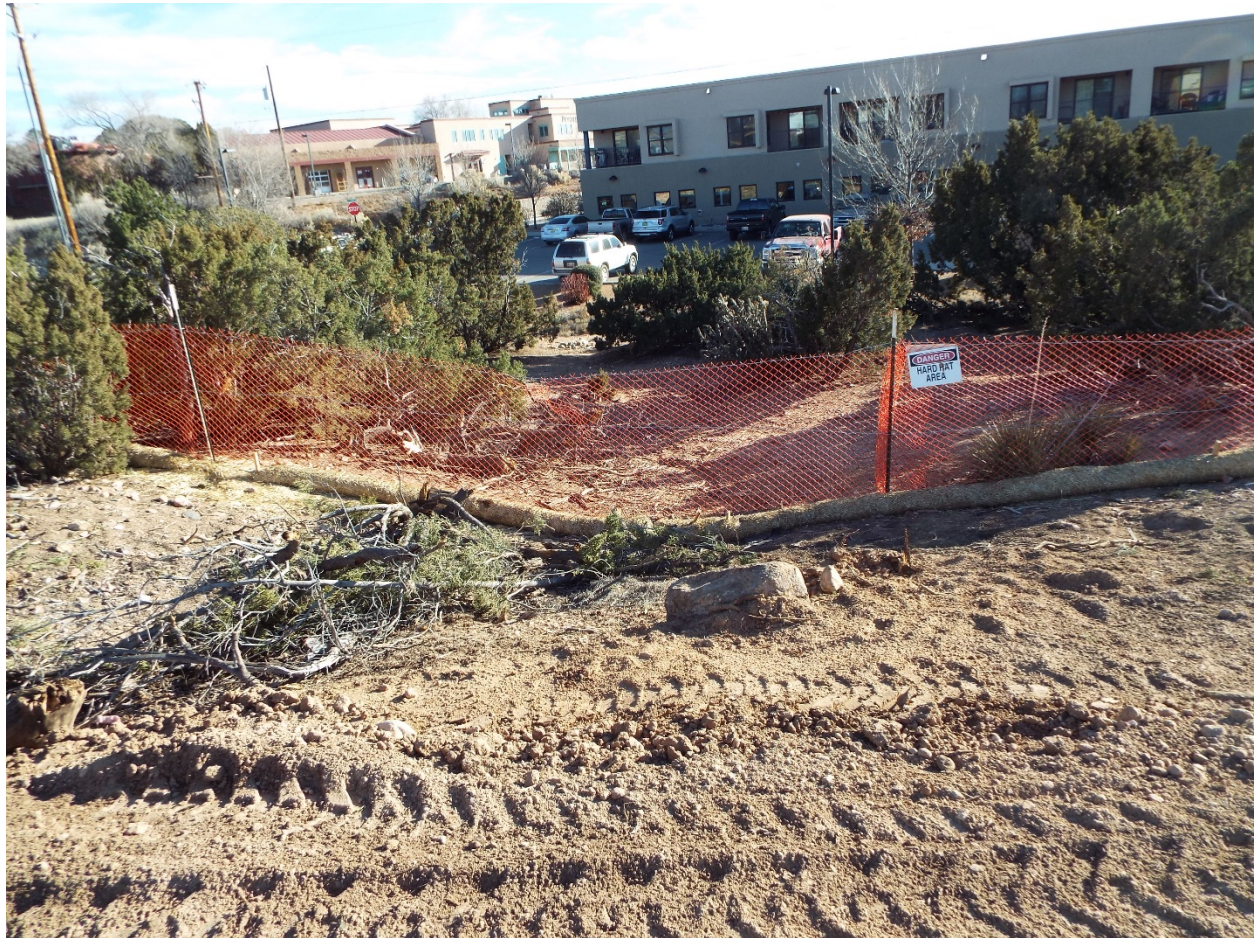
NMED/SWQB
Official Photograph Log
Photo # 7

Photographer: Daniel Valenta	Date: 12-21-2017	Time: 1452 Hours
City/County: Santa Fe / Santa Fe		State: New Mexico
Location: St. Bedes Episcopal Church; 1601 St. Francis Drive; Santa Fe, NM		
Subject: Possible discharge point, not named on Site Map or SWPPP

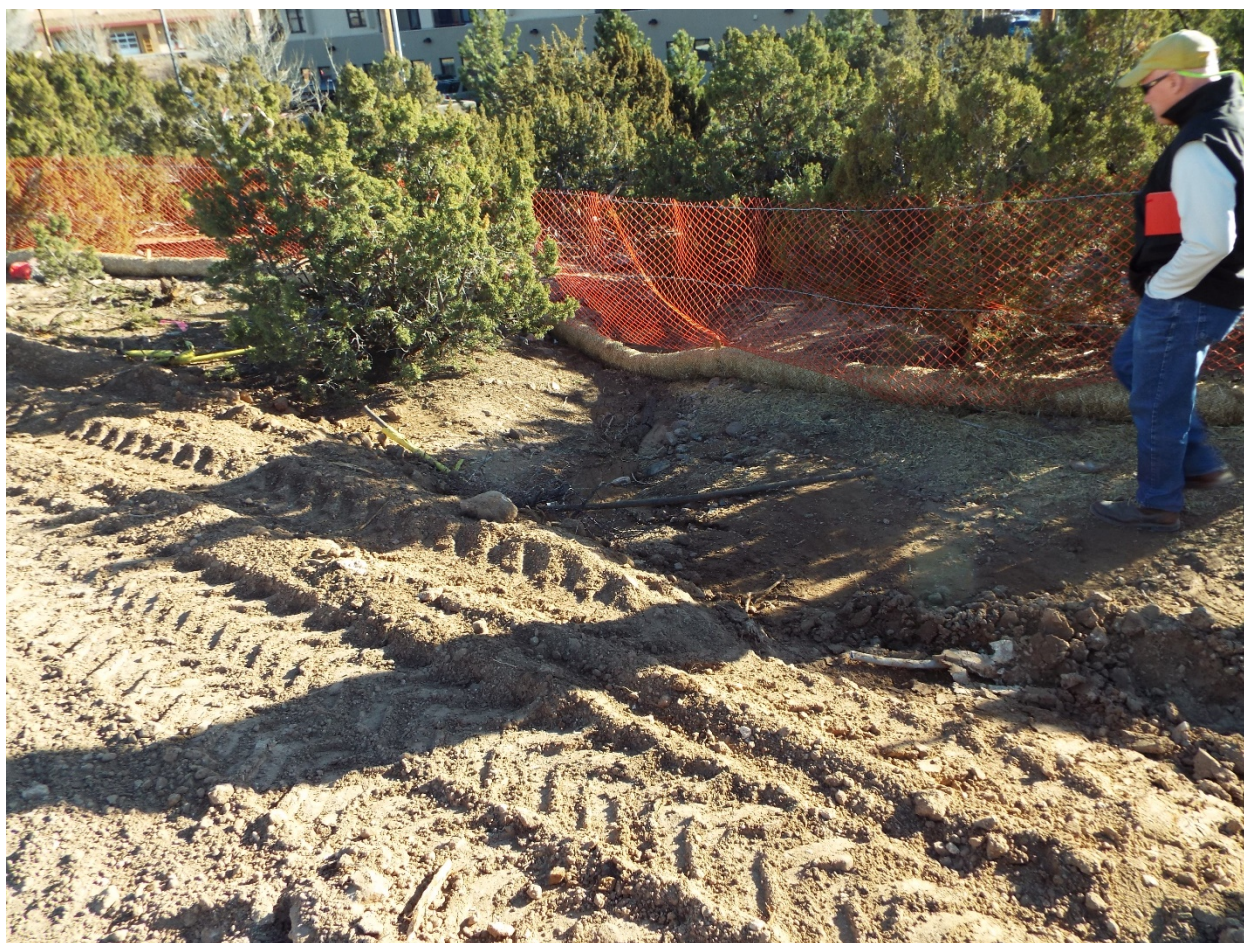
NMED/SWQB
Official Photograph Log
Photo # 8

Photographer: Daniel Valenta	Date: 12-21-2017	Time: 1456 Hours
City/County: Santa Fe / Santa Fe		State: New Mexico
Location: St. Bedes Episcopal Church; 1601 St. Francis Drive; Santa Fe, NM		
Subject: Possible discharge point, not named on Site Map or SWPPP

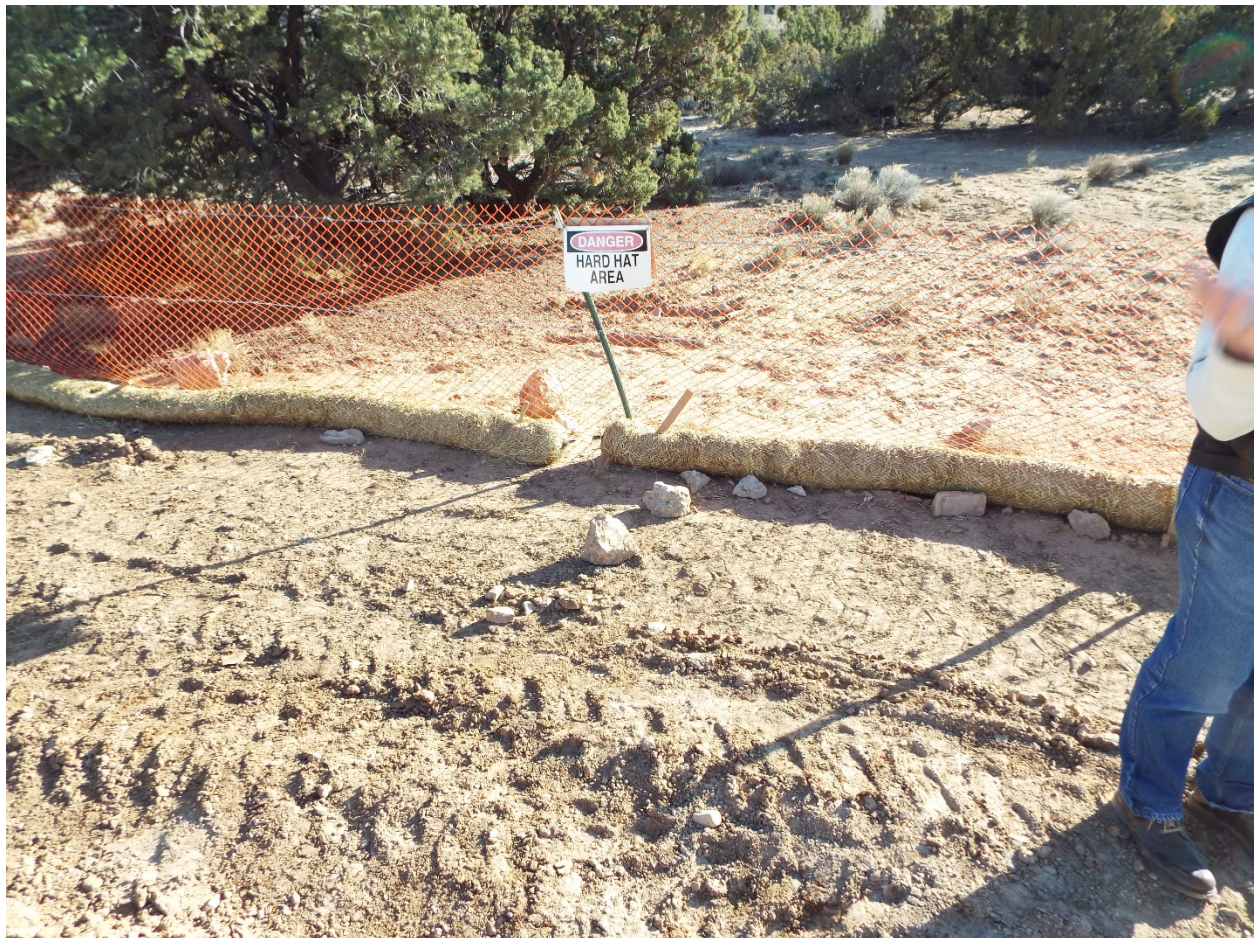
NMED/SWQB
Official Photograph Log
Photo # 9

Photographer: Daniel Valenta	Date: 12-21-2017	Time: 1457 Hours
City/County: Santa Fe / Santa Fe		State: New Mexico
Location: St. Bedes Episcopal Church; 1601 St. Francis Drive; Santa Fe, NM		
Subject: Perimeter best management practice (wattle); appears to need corrective action.
